SABINE REFUGE PROTECTION (C/S-18)
C/S-18-MSPR-0796-3
PROGRESS REPORT NO. 3
for the period
January 27, 1995 to July 29, 1996

Project Description

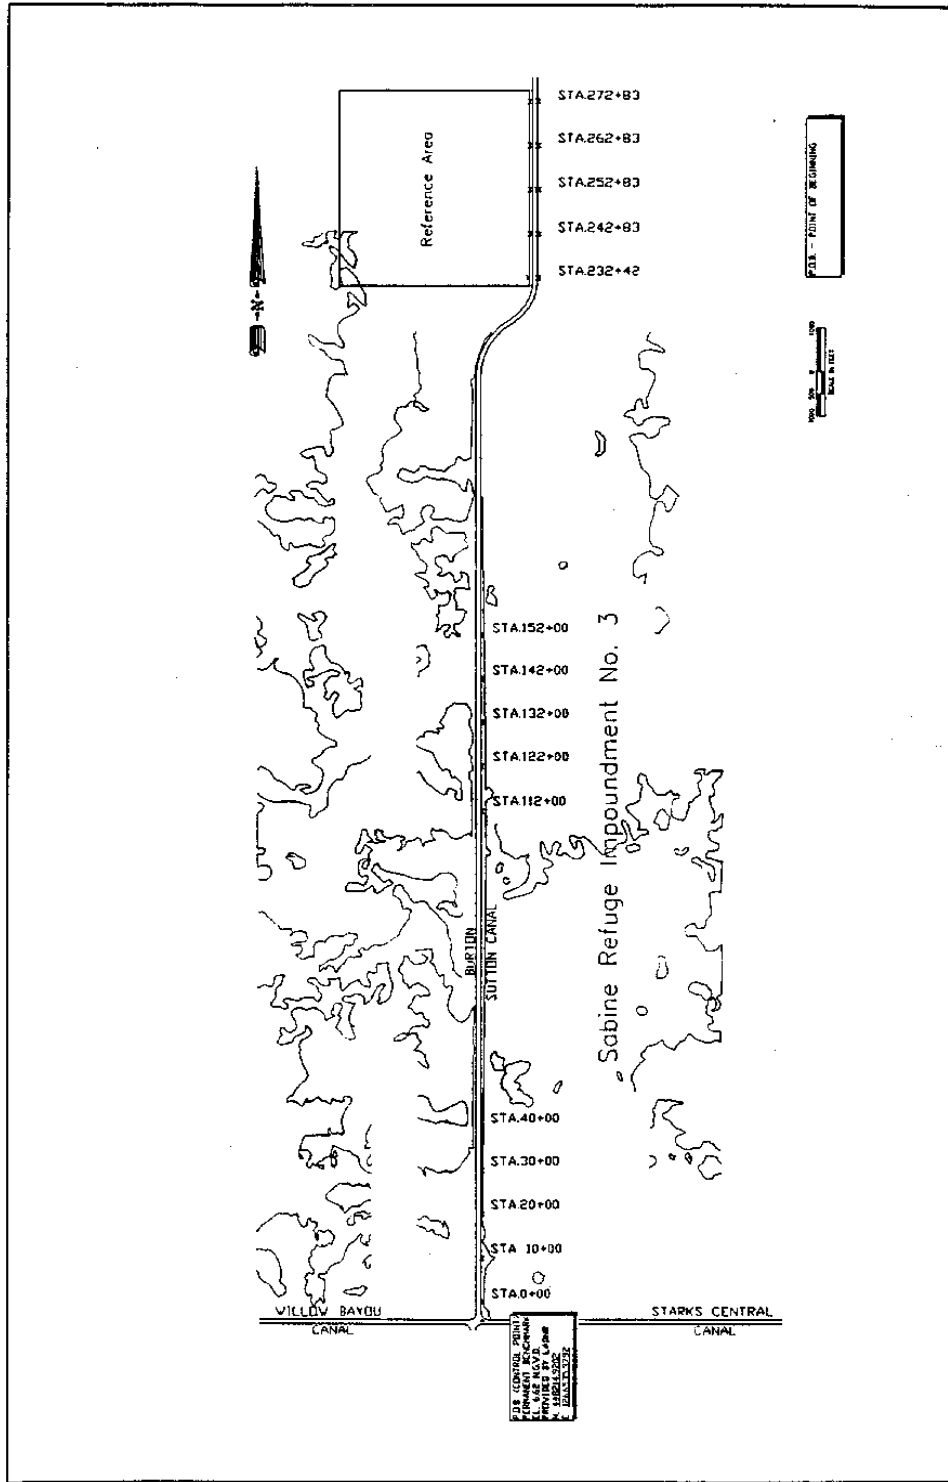
Figure 2. Plan view of the Sabine Refuge Protection (C/S-18) project rock dike along the Burton-Sutton Canal showing the location of the survey cross sections established to monitor shoreline movement.

Shoreline Markers: During August 1995, Professional Engineering and Environmental Consultants of New Orleans completed a shoreline and cross-sectional survey of the Burton-Sutton Canal. This baseline survey data will be compared to future data sets to evaluate project success. Representative plan view and channel cross-sectional drawings from the survey are provided as examples in figures 2 and 3. The survey will be repeated in 1998.

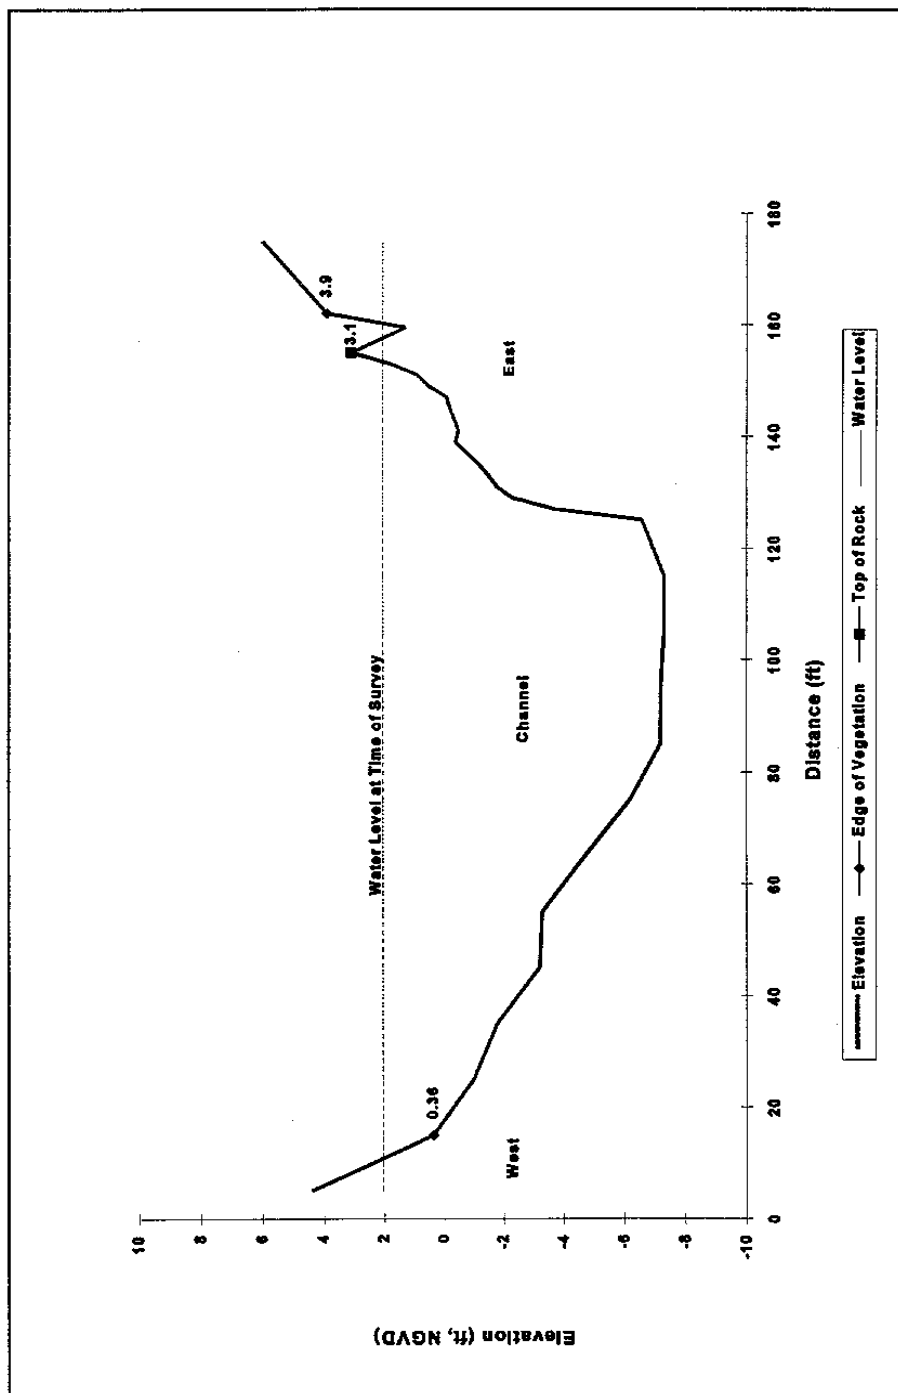
Figure 3. Cross-sectional view of the Burton-Sutton Canal at station 272+83 on the west side of Impoundment No. 3 at Sabine National Wildlife Refuge, showing channel profile, locations of the vegetative edge, the Sabine Refuge Protection (C/S-18) project rock dike, and the water level at the time of the survey in October 1995.
